Esthetic Casebook

Esthetics with the Straumann® Dental Implant System

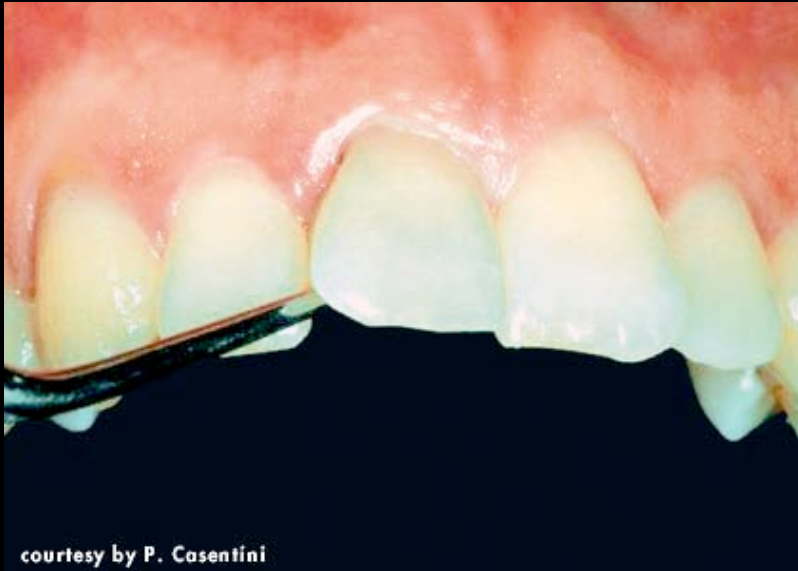
Figure 01

Right central incisor with horizontal fracture.

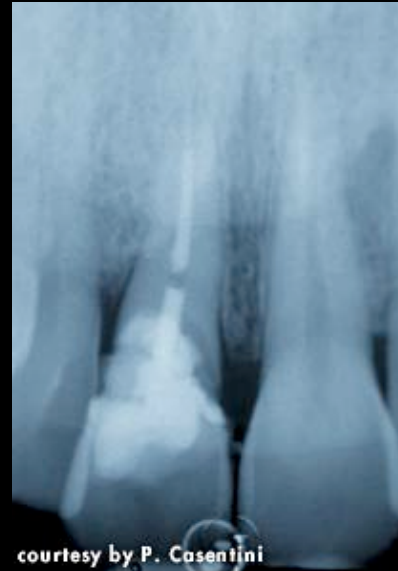
Figure 02

Radiographic examination: there is absence of infection and bone height is substantially maintained.

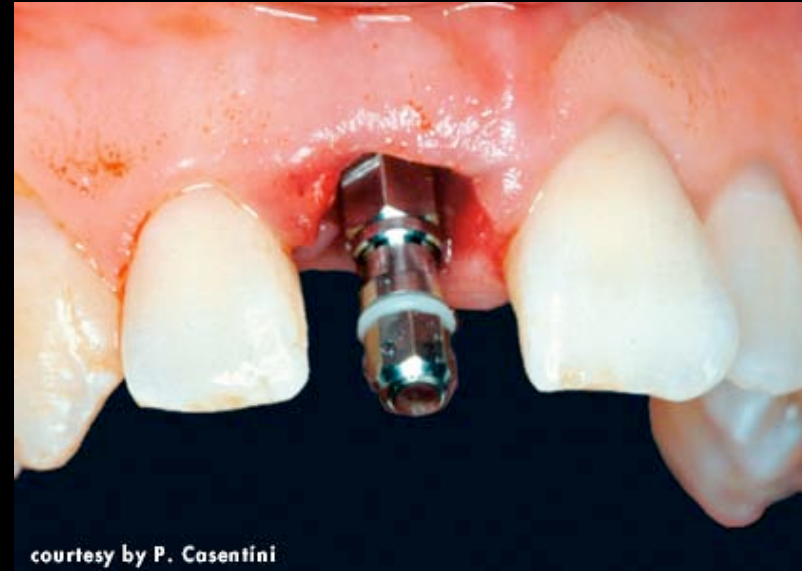
Figure 04

Implant has been inserted: implant shoulder is positioned at crestal level and 2.5 mm apical to the gingival margin.

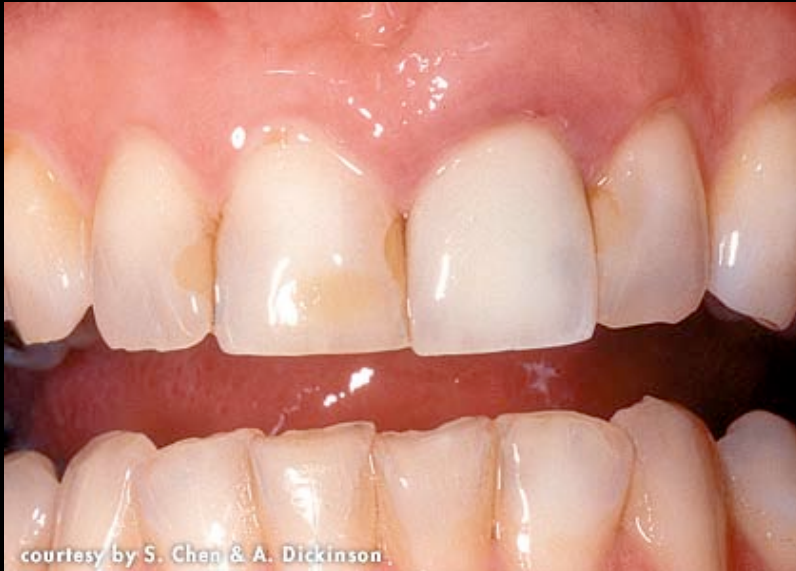
Figure 01

Appearance of the upper left central incisor at initial presentation in June 1999. Note that the crown was displaced coronally and the gingiva was inflamed. The proximal restorations of the adjacent teeth had discoloured.

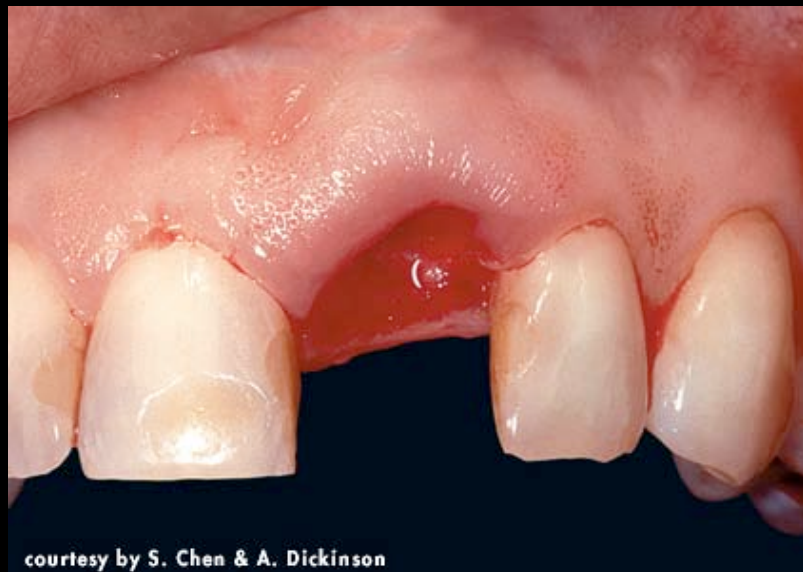
Figure 03

Implant surgery was completed in June 1999. Tooth 21 was atraumatically extracted without raising a flap, thus keeping the soft tissue cuff and the alveolar bone intact.

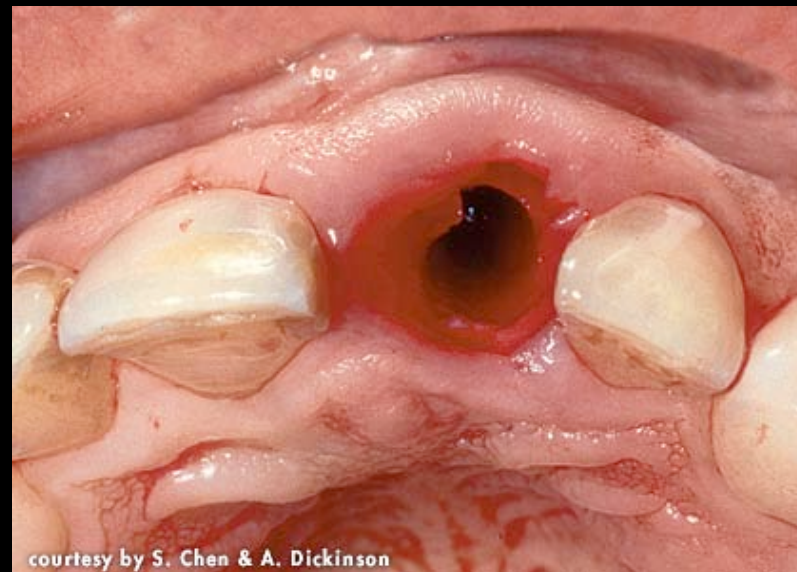
Figure 04

Inspection of the socket showed that damage to the labial plate was minimal. A decision was therefore made to place the implant without raising a flap. The socket was prepared in accordance with the surgical protocol of the Straumann® Dental Implant System. The osteotomy was directed palatally to ensure an optimal axial orientation of the implant. The coronal palatal wall of the socket was prepared with a profile drill to accommodate the flared collar of the implant.

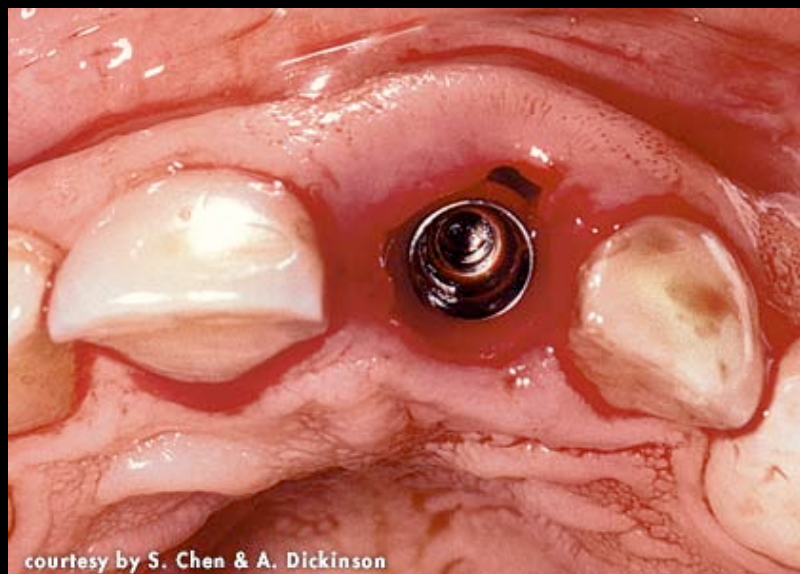
Figure 05

A Straumann® Standard Plus Implant, Ø 4.1 mm RN (SLA® Ø 10.0 mm), was selected and installed. The collar of the implant was submerged 2.0 to 3.0 mm from the mid-labial gingival margin. At this time, the horizontal defect dimension between the implant collar and the labial cortical bone was determined to be 1.0 to 2.0 mm in width. Thus, no bone augmentation procedures were required.

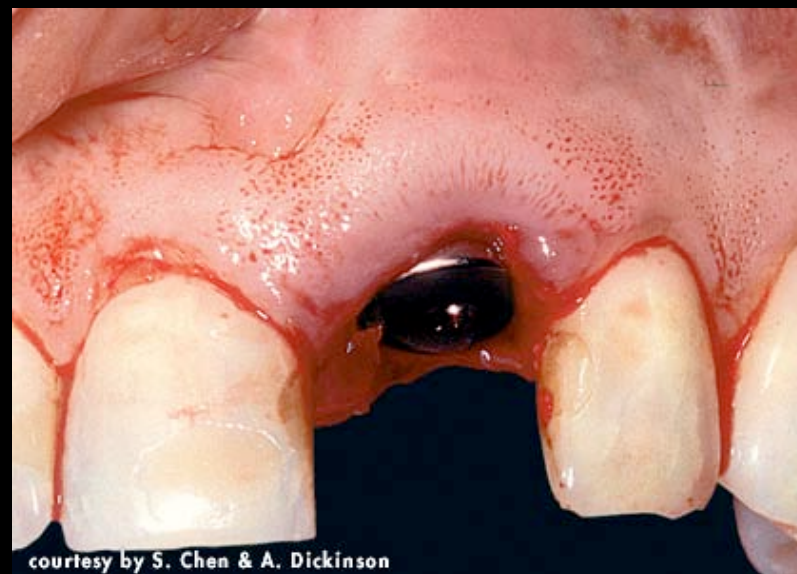
Figure 06

A 2.0 mm extended healing cap was attached to the implant to allow semi-submerged healing. Sutures were not used. The partial denture was adjusted to relieve the implant site, and delivered to the patient.

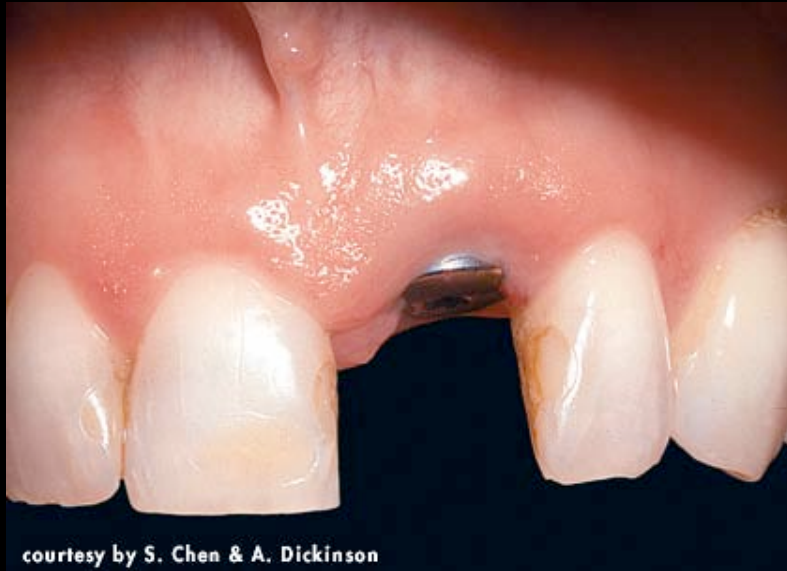
Figure 07

Systemic antibiotics were prescribed for 7 days postoperatively. In addition, the patient was asked to rinse twice daily with 0.2 % chlorhexidine solution for two weeks. Brushing of the implant site was instituted after two weeks of healing. This image illustrates the clinical conditions after 3 months of uneventful healing.

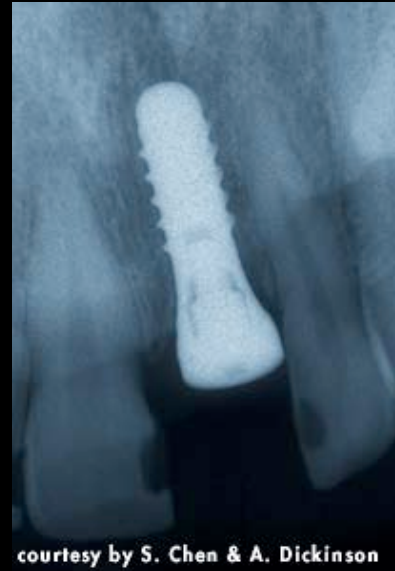
Figure 08

A periapical radiograph of the implant obtained after 3 months of healing confirmed an ideal bone response. The implant was clinically integrated at this time.

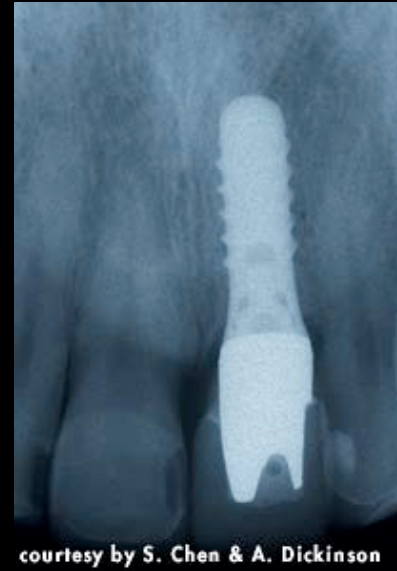
Figure 12

A radiograph obtained in May 2004 demonstrates ideal bone conditions associated with the implant.

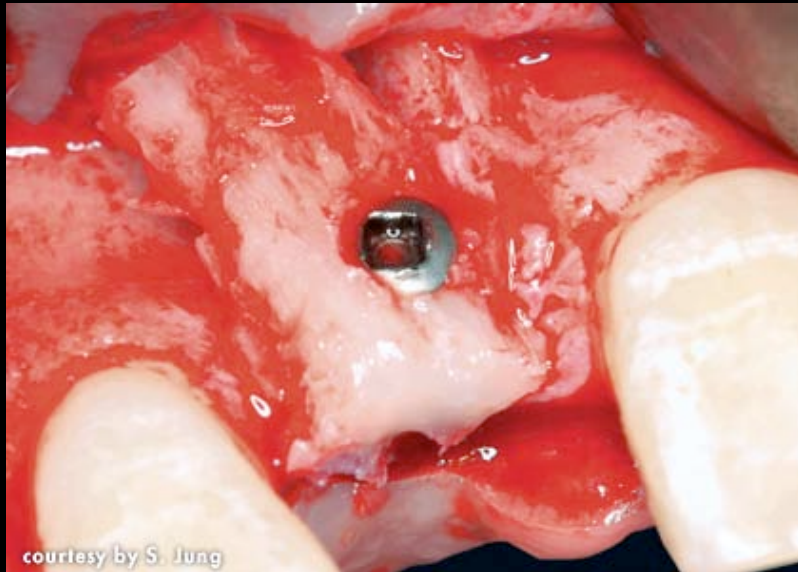
Figure 03

Autogenous corticocancellous block graft from the lateral mandibular ramus is used to fill the defect.

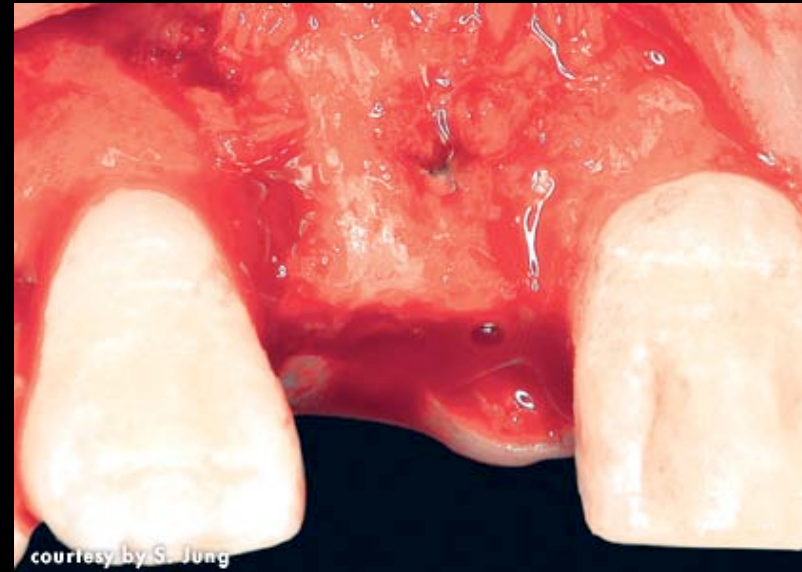
Figure 04

Additional autogenous particulate bone chips are added around the block graft.

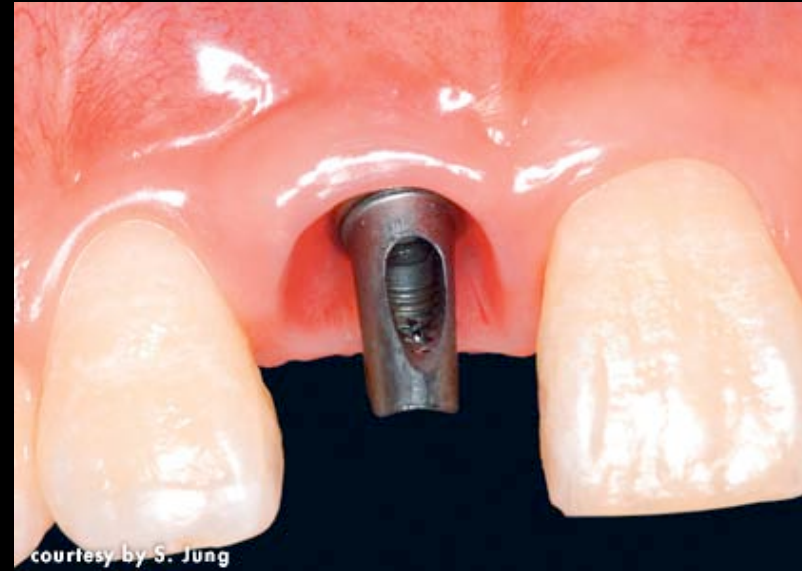
Figure 14

The soft tissue conditioning was achieved with a provisional crown. A RN synOcta® 15° angled abutment was inserted into the Straumann implant with a torque of 35 Ncm using a SCS screwdriver.

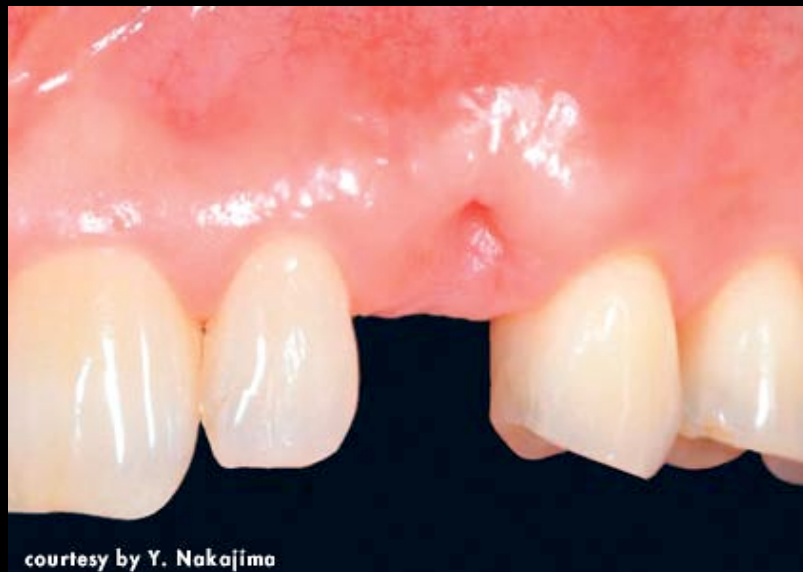
Figure 01

Deciduous Tooth # 63 was removed two months prior due to caries.

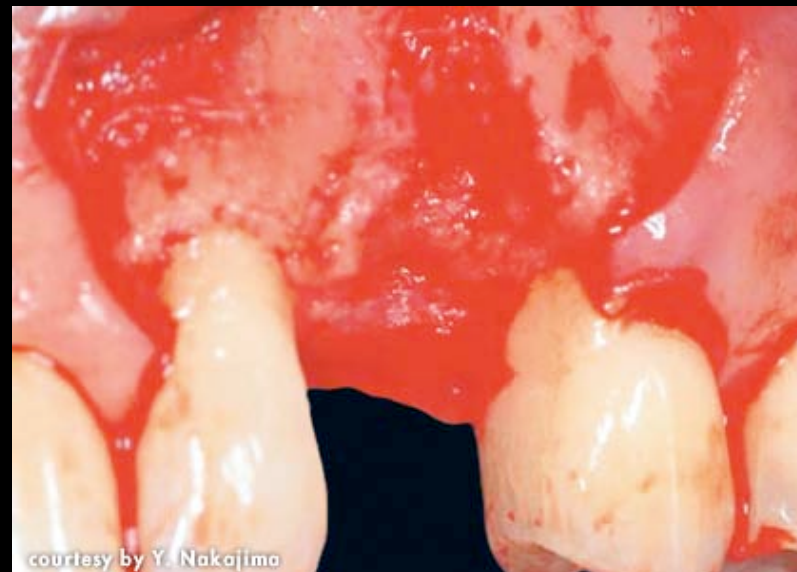
Figure 02

Palatal incisions and divergent release incisions were performed at the site of # 23. A muco-periosteal flap was elevated without any damage to the papilla area. A 2 wall bony defect presented and GBR procedure was necessary.

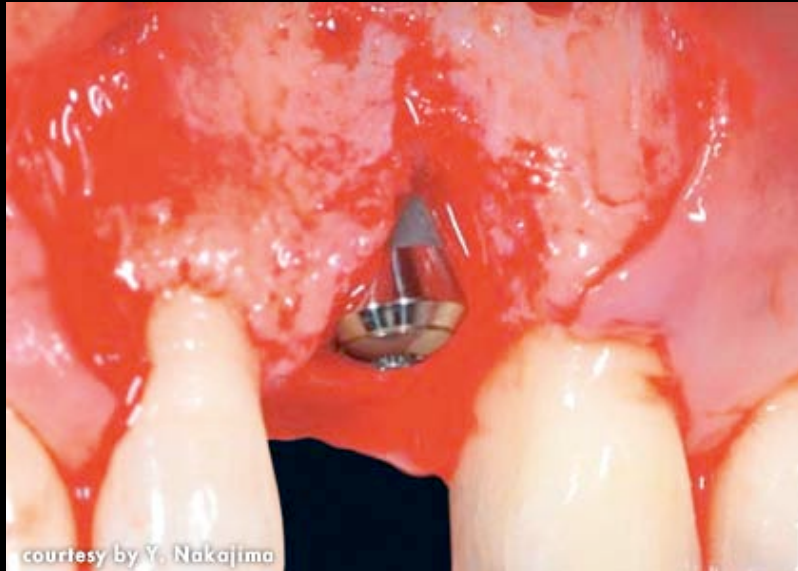
Figure 03

A Straumann® Standard Plus Implant, Ø 4.1 mm RN (SLA® 12.0 mm), was placed. The axis was slightly angulated labially.

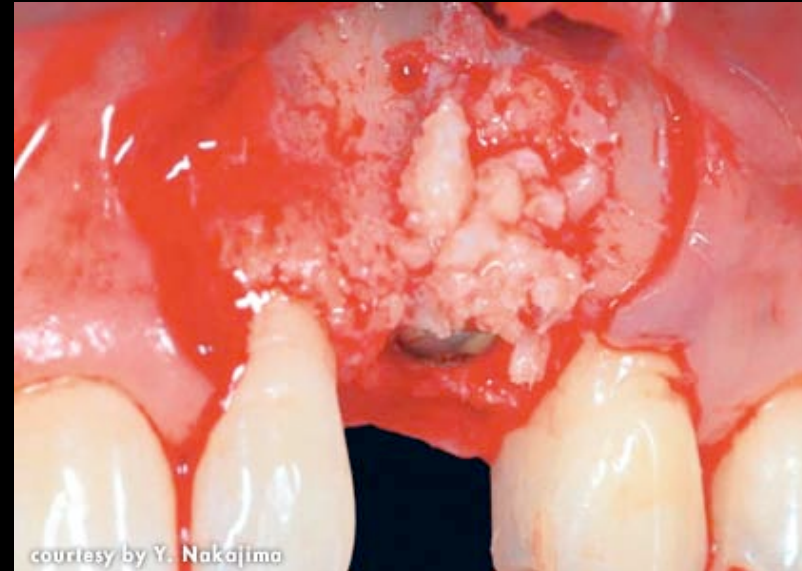
Figure 04

Autogenous bone chips were harvested from the site's apical region and placed into the bony defect around the implant.

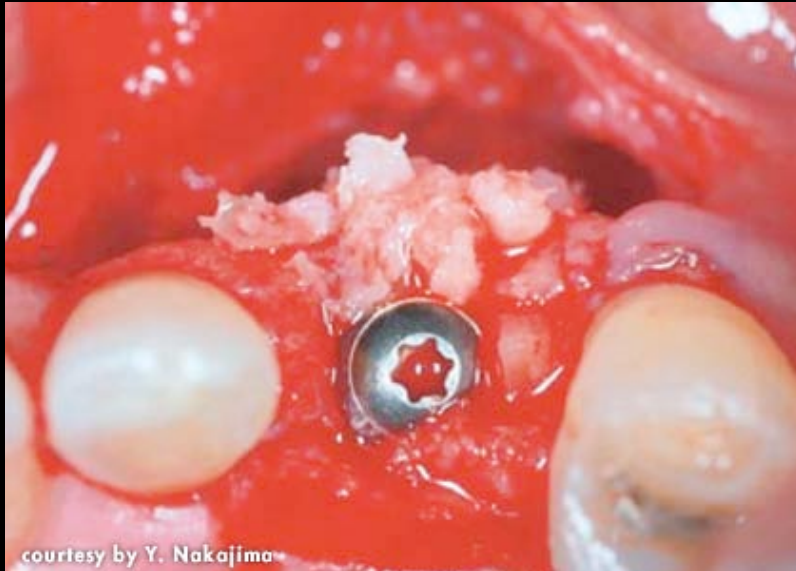
Figure 05

Autogenous bone graft material was “overfilled” on the bony defect.

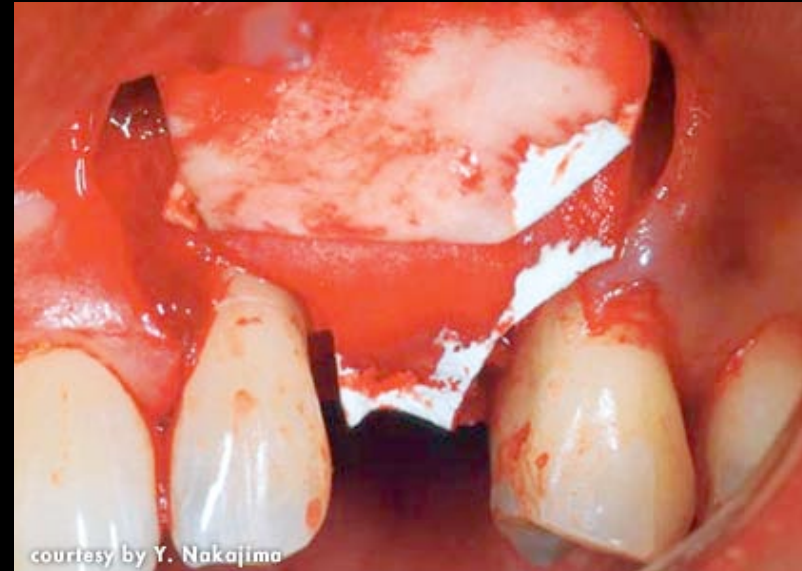
Figure 06

A resorbable membrane was placed on the bone graft.

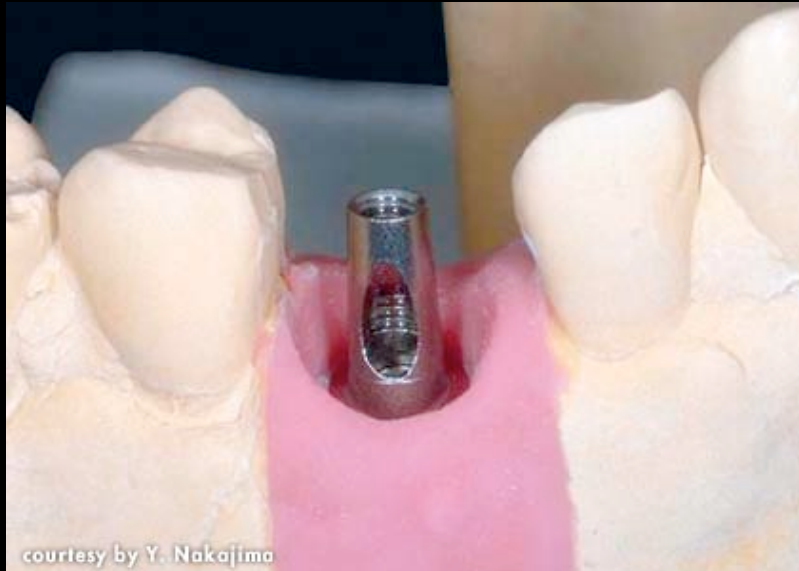
Figure 11
Selection of a RN synOcta® angled abutment.

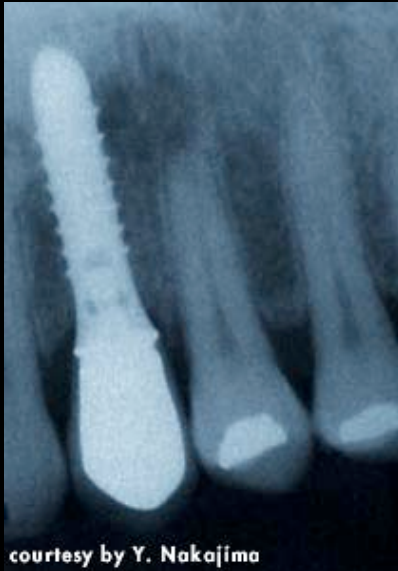
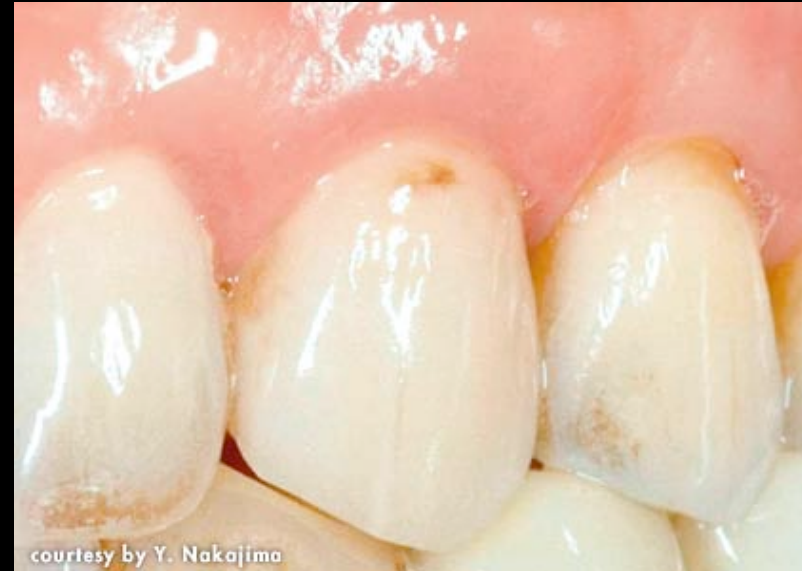
Figure 15/16

X-ray at 2 years after implantation and 2-year follow-up of implant site. Implant was controlled by the Cumulative Interceptive Supportive Therapy (CIST) program and well maintained implant tissue was observed for 2 years without any complications.

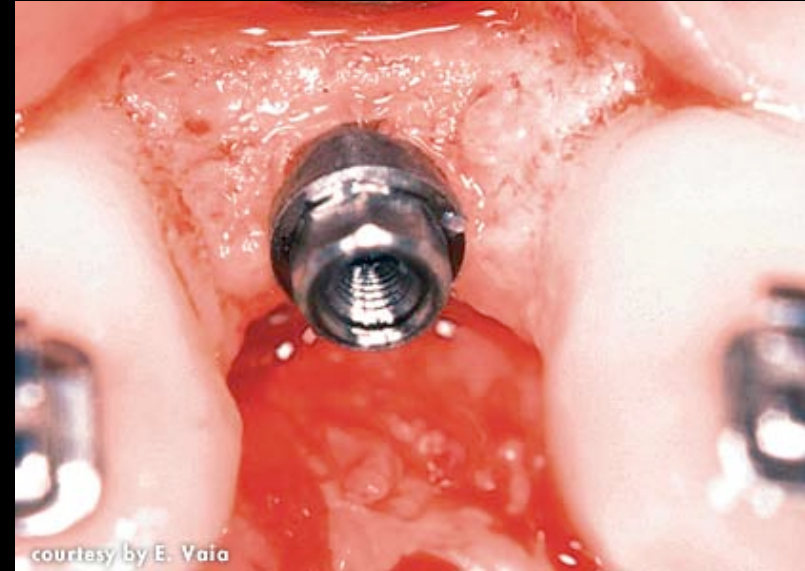
Figure 4:
NN Implant fitted in the 12 region.

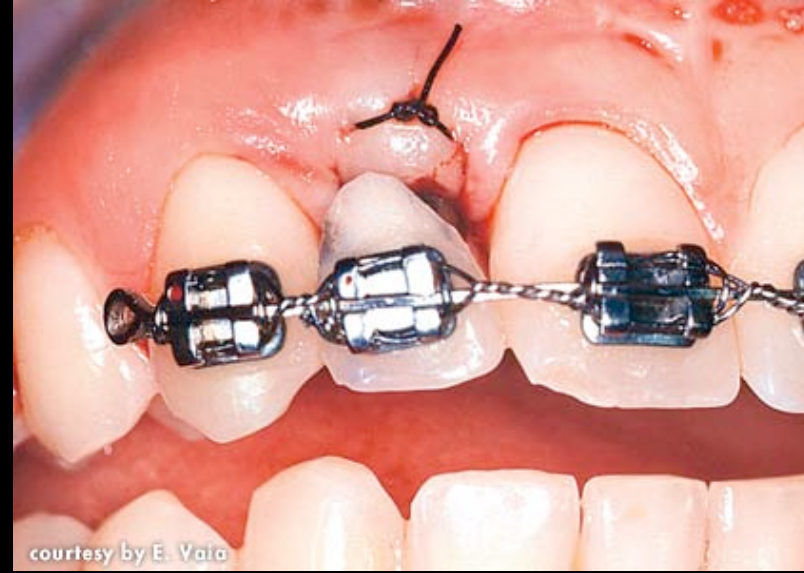
Figure 6:

Repositioning of the passive orthodontic wire to which the missing tooth is attached. Note the absence of contact between the tooth and the implant to avoid premature functional loads during the osseointegration stage.

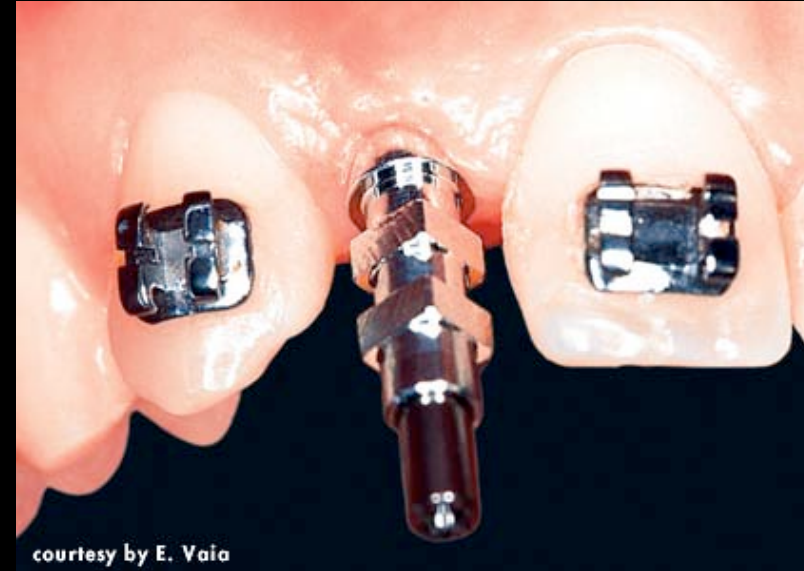
Figure 8:

NN Impression post is screwed onto implant to take the final impression.

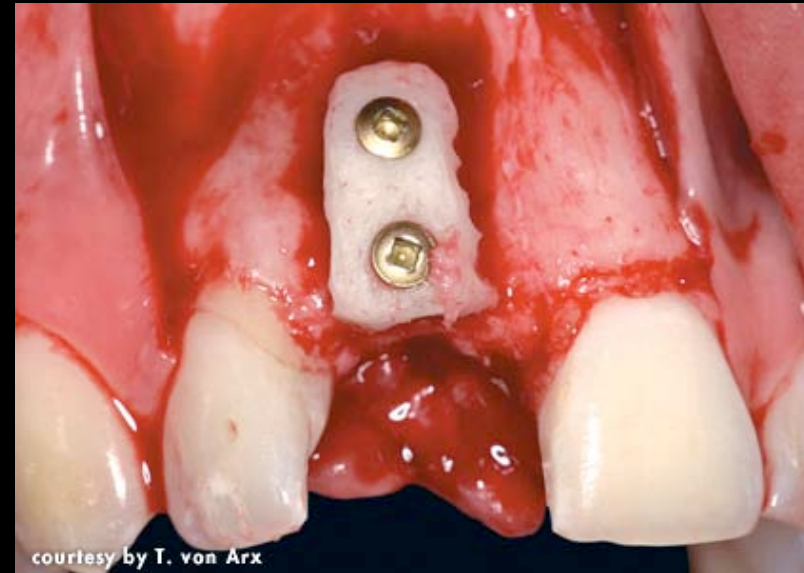
Figure 4:

A block graft was harvested from the symphysis and stabilized with two miniscrews for lateral ridge augmentation.

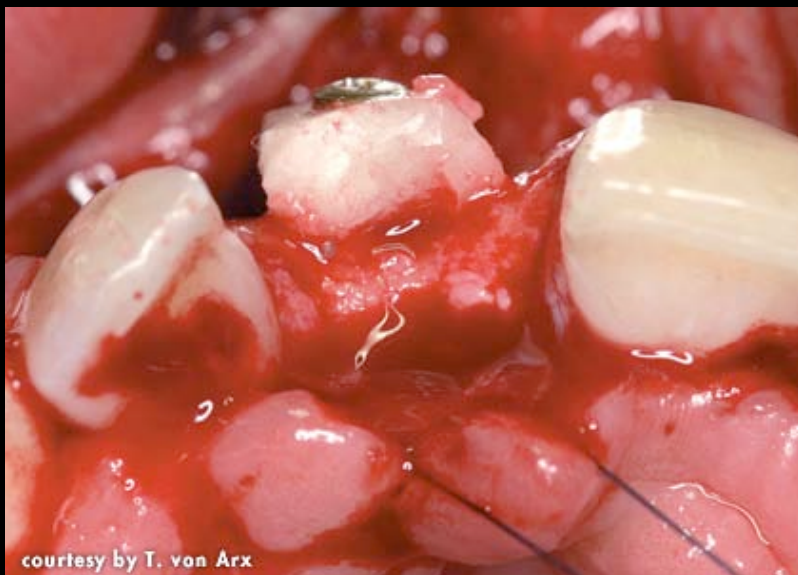
Figure 5:

The occlusal view shows the enlargement of the alveolar crest to a width of 6 mm.

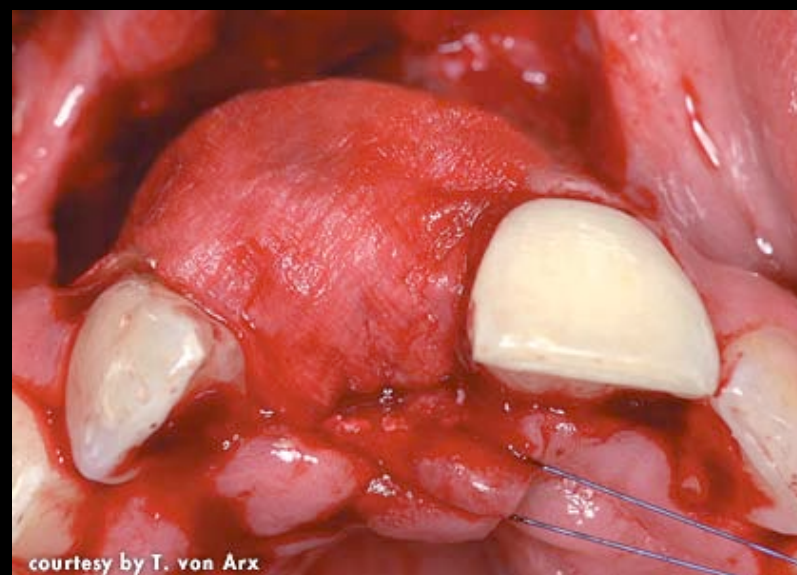
Figure 6:

Following the placement of xenogenic bone substitute particles around and onto the blockgraft, a collagen membrane was applied in a double layer-technique.

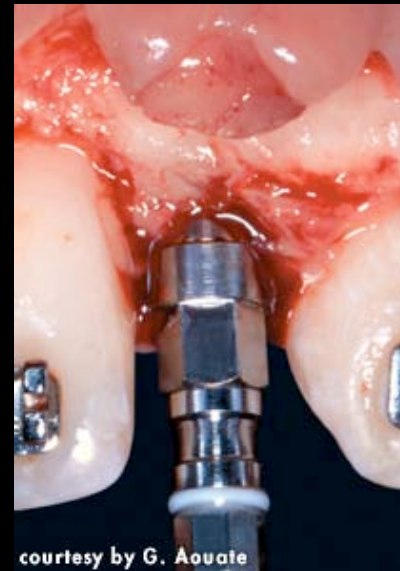
Figure 2:

Straumann® Standard Plus Implants, Ø 3.3 mm NN (SLA® 10.0 mm), are used to replace both missing lateral incisors in the maxilla.

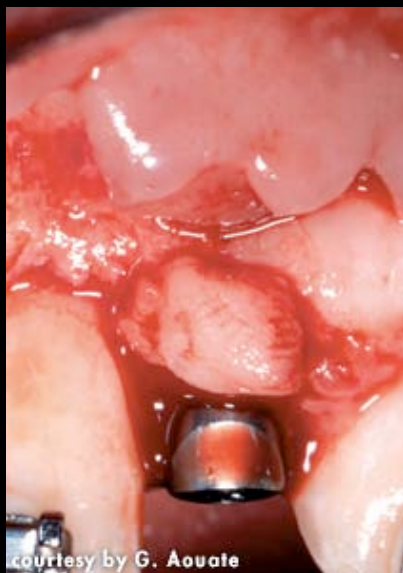
Figure 3:

A free connective tissue graft, harvested from the tuberosity area, is intended to improve the labial aspect of the implant site. The healing cap contributes to the soft tissue enhancement.

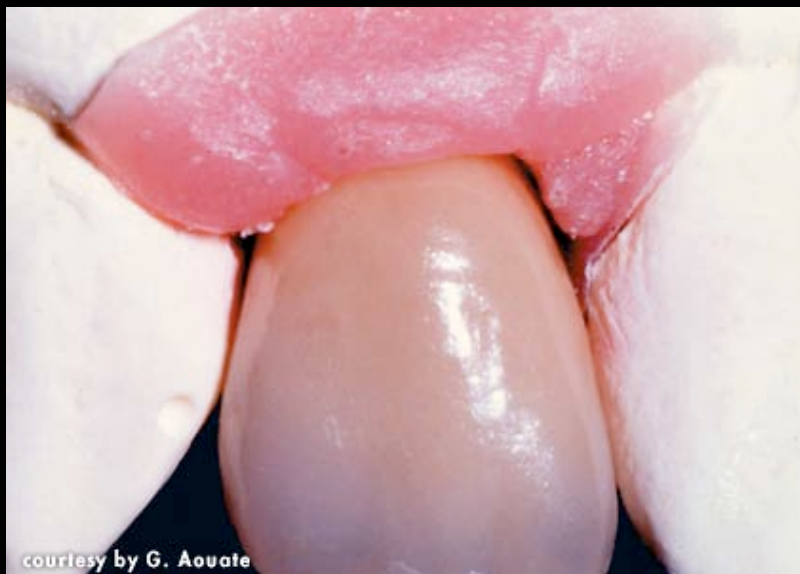
Figure 7:

The all-ceramic crown placed on the model with gingiva mash helps to evaluate the emergence profile.

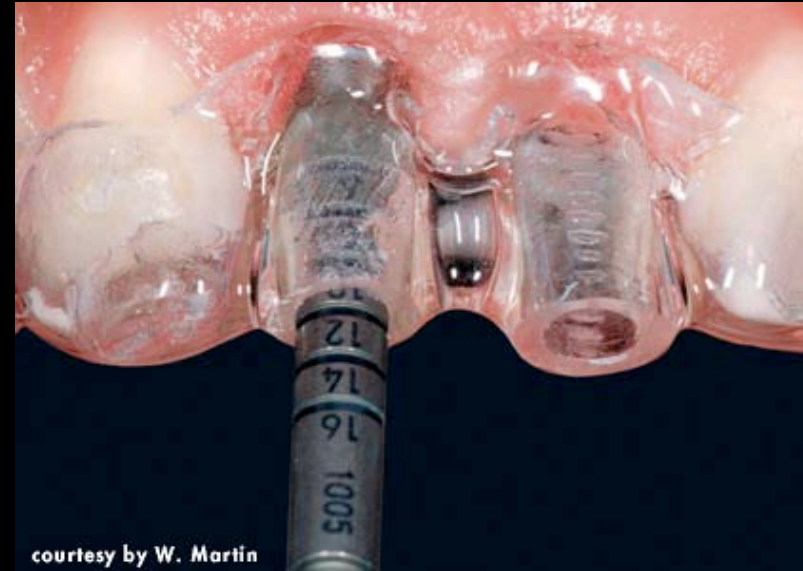
Figure 4:

A surgical template was utilized to communicate the desired mesio-distal and oro-facial position of the implants to the surgeon. In addition, another template was utilized to capture the proper vertical dimension of the implant position.

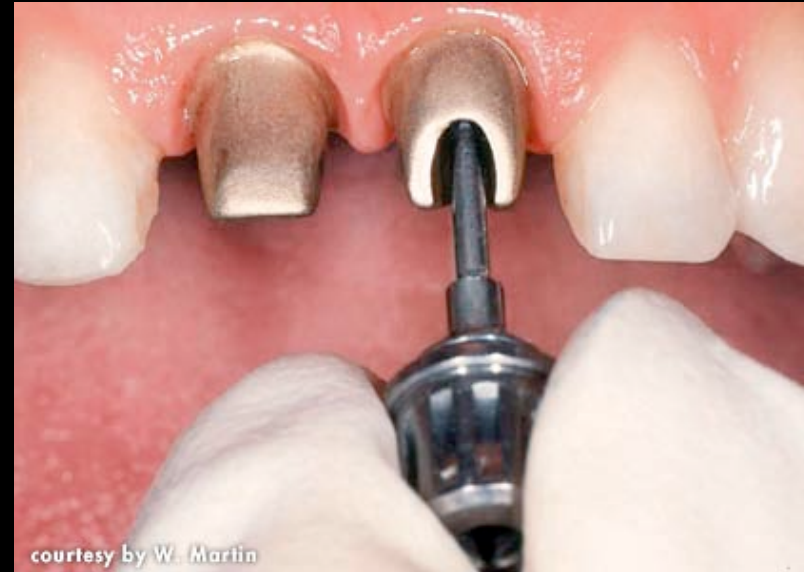
Figure 10/11:

At delivery, the implants are irrigated and dried, and the synOcta® 1.5mm abutments are positioned and torqued to 35 Ncm. The customized copings (synOcta® gold copings) are then placed and also torqued to 15 Ncm. Customized copings (synOcta® gold copings) provide for screw-retained machined components at the shoulder level, and an accessible and contoured cement margin for the definitive restorations.

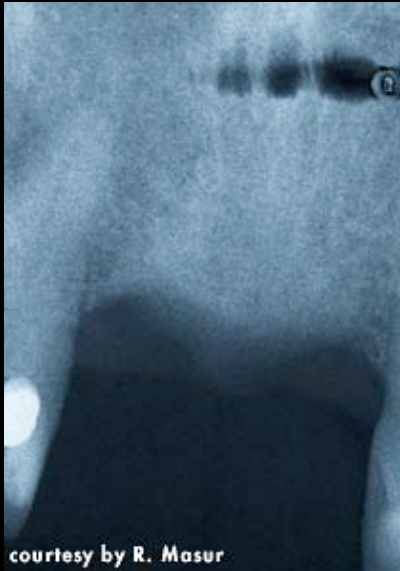
Figure 3:

The x-ray demonstrates the severe vertical bone defect at the missing teeth and of the mesial septum of the neighboring teeth.

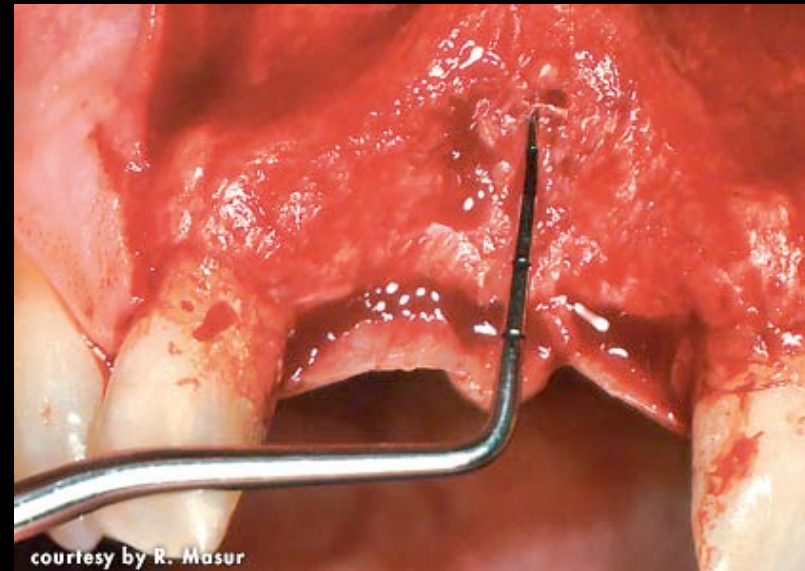
Figure 4:

The surgical site demonstrates the three-dimensional defect. A vertical bone loss of 8.0 mm in the labial interdental region and a horizontal component of approximately 6.0 mm bone loss also becomes apparent.

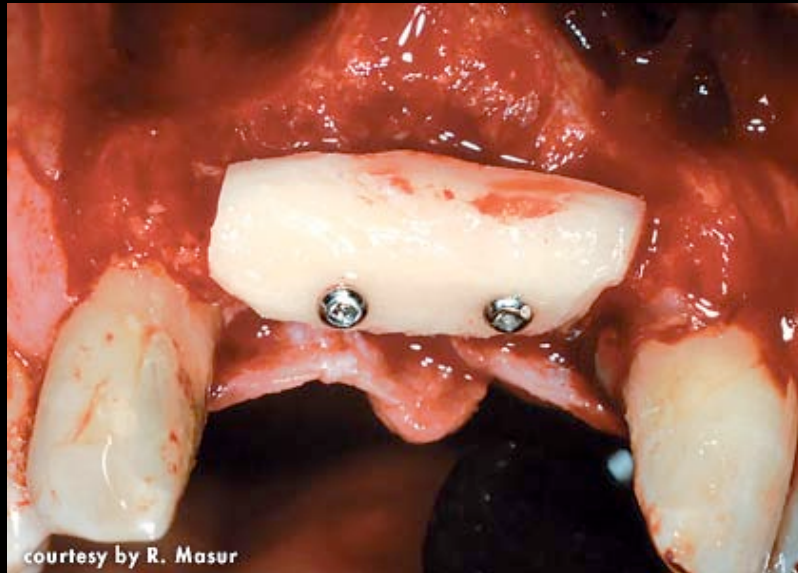
Figure 5:

An autogenous block graft harvested from the right mandibular ramus is fitted precisely to ensure bony regeneration.

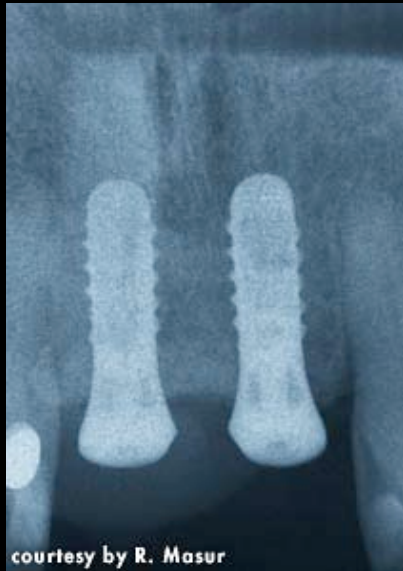
Figure 13:

3 months after implant insertion the harmonious integration of the block graft and the resulting successful vertical augmentation of the defect is clearly visible on the radiograph.

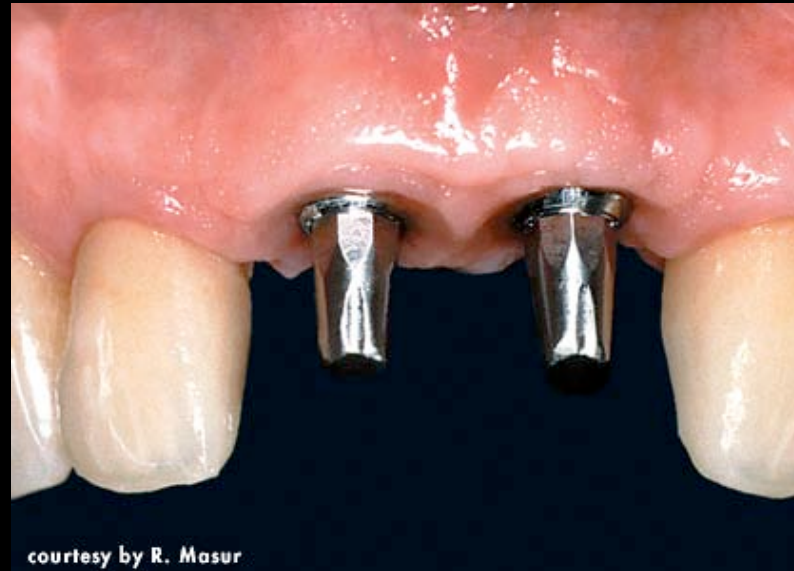
Figure 14:

RN synOcta® cementable abutments and well-shaped soft tissue after trial wearing of the metal ceramic crowns. The implant shoulders are only minimally submerged to provide optimal preservation of the reconstructed bone. The skillful dental technician's reconstruction optimizes the impression of the well-shaped soft tissue and for esthetic closure of the interdental space.

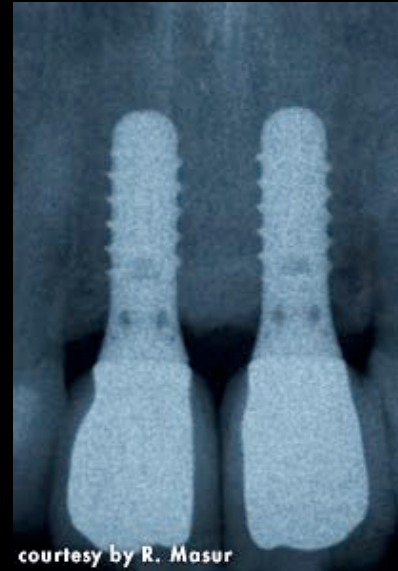
Figure 16:

Control x-ray 6 months after prosthetic reconstruction and 9 months after transgingival implant insertion. In keeping with the principle of biologic width, the bone level is maintained at the SLA®/smooth surface interface.
